SSV Architects
ARCHITECTURE • PRESERVATION

BUTTERFIELD SCHOOL FEASIBILITY & REUSE STUDY

CONDITIONS ASSESSMENT & TREATMENT RECOMMENDATIONS

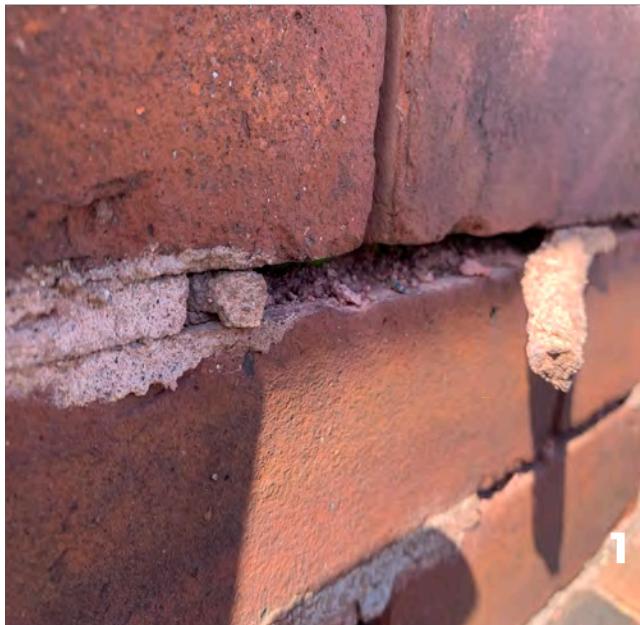
Through a visual inspection, the bricks utilized at Butterfield School appear to be quite durable, having proven themselves to be fairly weather-tight over the course of the last century. Inspection of the masonry yields that many of the brick faces are rough, suggesting spalling. Spalling is one of the many processes in which brick and stone deteriorate; being particularly prevalent in 'spongy' stone species like limestone, sandstone and brick. It occurs primarily as a result of the many air pockets that form during the firing process. When water is allowed to flow through the brick, it can over time dissolve some of the minerals binding the material together. The result is crumbling – typically of the outer faces, where moisture is most readily absorbed.

A mild degree of spalling is typical, even at newer masonry structures. The mild level of spalling present at Butterfield School can comfortably be categorized as uncerning.

The lack of advanced spalling here is fortunate, given that the only effective solution is replacement of affected units. **It follows that no related interventions are necessary at this time.**

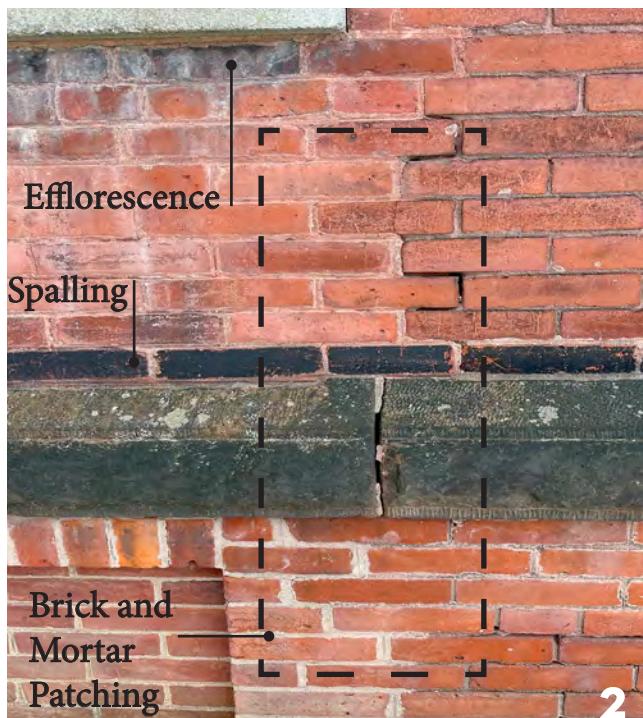
What is more prevalent on the school's exterior walls is efflorescence. Much like spalling, this condition is caused by masonry units absorbing moisture. The resulting white stains are merely salts deposited as the bricks leach moisture and are typically no cause for concern. Efflorescence can more readily be observed in the spring, when moisture absorbed into the walls during the winter (often containing dissolved de-icing salts) begins to weep. Removal of efflorescence is by no means necessary. If desired, staining can be removed via gentle cleaning with water.

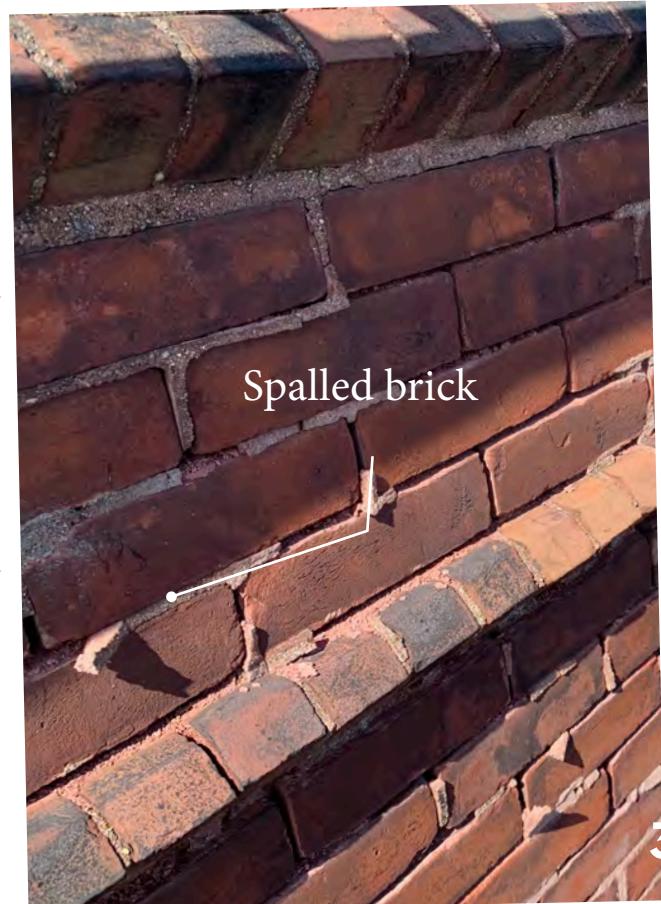
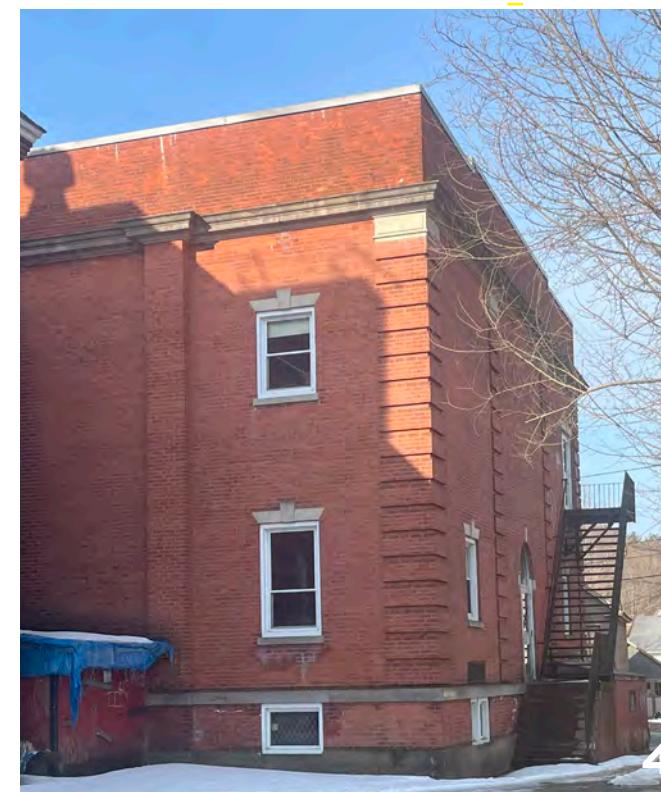
The building foundation is poured concrete. Notable cracks have been sealed and do not seem to be suggestive of a greater (that is, structural) problem. Any minor cracks that arise can be patched just as they have been (with caulk or mortar). If existing cracks grow larger over time, a structural engineer should be engaged.

As mentioned, architectural precast has here been employed for window sills, cornices and headers. All decorative precast pieces have proven durable and show little to no deterioration. That said, areas of precast that receive a higher level of wear and tear are in need of some intervention. Neither is drastic, especially considering their unlikelihood of allowing water to enter the building envelope. Notwithstanding, any cracked pieces of precast should be replaced in-kind. All mortar joints at the stair should be cut and comprehensively re-pointed with mortar closely matching the existing.

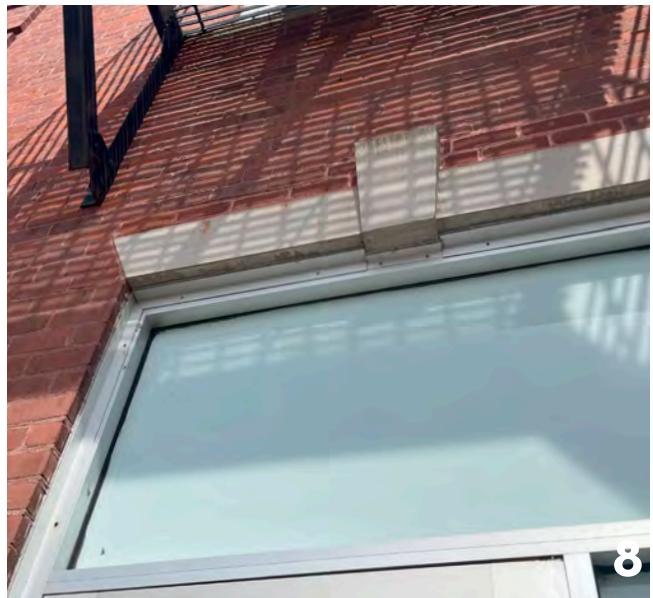
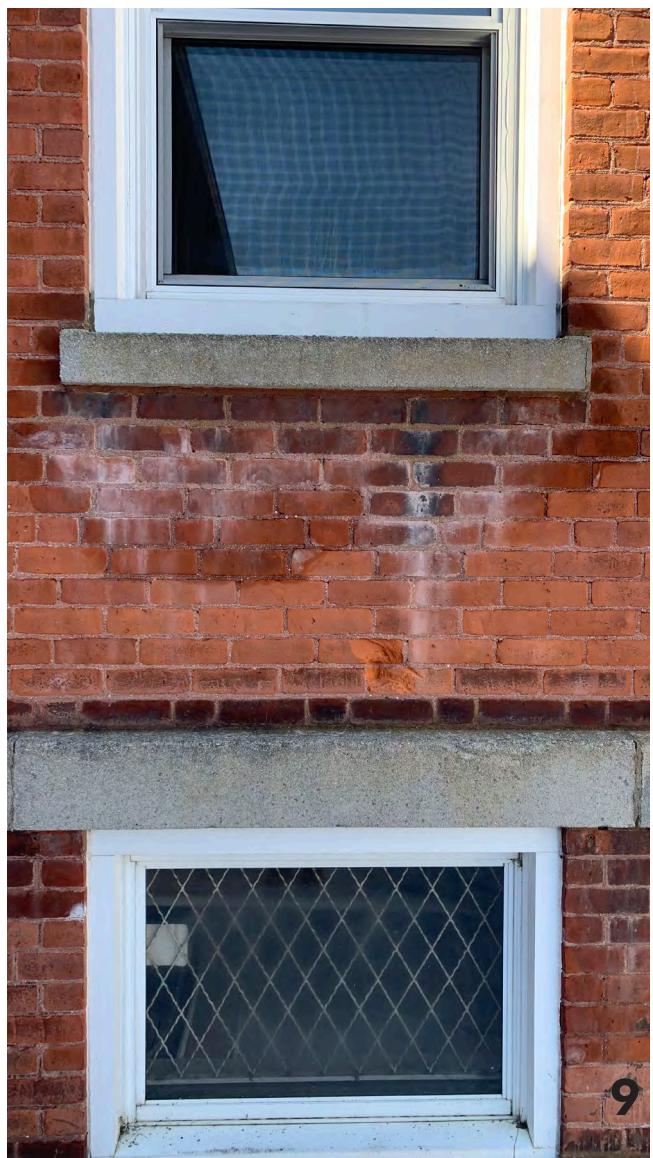
The Palladian window at the second floor of the east wing seems to be in relatively good condition, as well as the exterior casings are in just as good condition despite being exposed to the elements. We anticipate that the building's stewards are receptive to exterior deficiencies as they arise. Such proactive measures as re-painting casings and cleaning sash are integral to windows' long-term protection.

All that said, we have observed that the building's existing windows are in working order. If required improvised solutions such as applying cut Plexiglas over certain areas, though aesthetically questionable, can be effective in protecting these character defining features from weathering.

We do not recommend that the town immediately replace the existing storm windows. However, we do recommend that the building's stewards keep a careful eye on them and, at the sign of any leak or glazing failure, replace them with custom fabricated low-profile storm panels. Operable and inoperable options are available (the latter requiring that a member of the maintenance crew change out the glass panels for screens in the spring and vice versa in the fall).

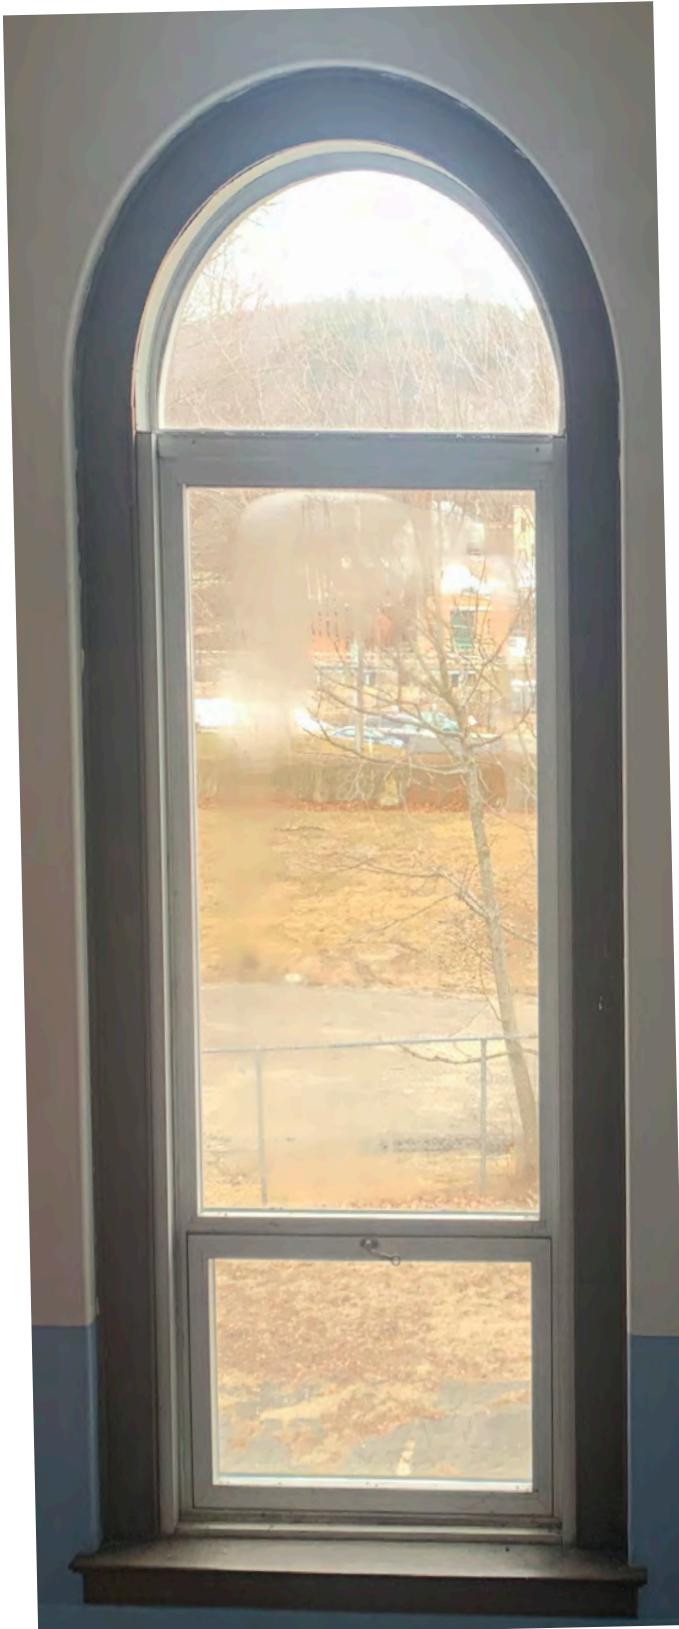
Smaller operable windows at the north of the building tend to be in worse condition. It is not uncommon that less visible windows such as these receive less proactive care. All windows would be tested for operability during future site visits, and their functionality would be determined.

However, much like the larger windows these sash show little to no glazing failure and their casings are in equally good condition. That is to say, perhaps these windows could benefit from new weatherstripping and cords. All should be re-balanced.

If required in the future, replacement of the existing storm windows with low-profile storms are recommended, but more typical aluminum storms have a lower price tag and would minimally disrupt the building's overall appearance (as this is the least visible elevation). However, as previously mentioned, these storm windows have a notably shorter lifespan than those offered by Allied and other manufacturers of that caliber.

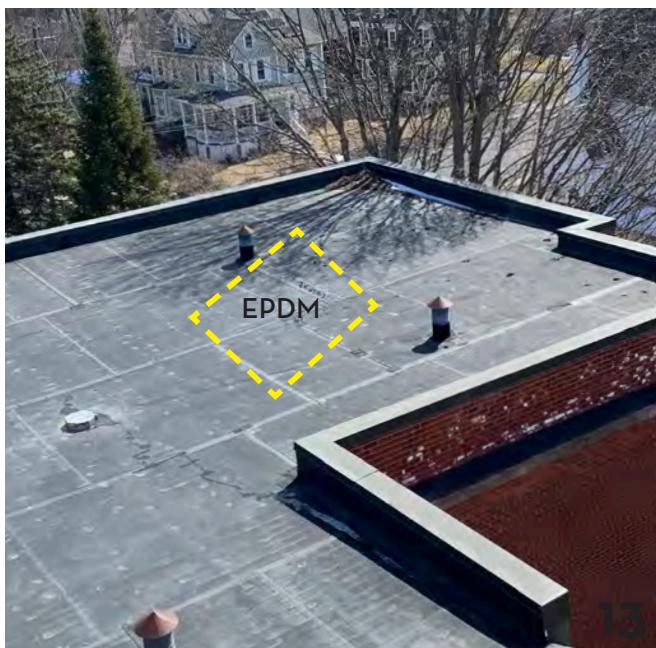
As discussed in the 'Character Defining Features' narrative, the Butterfield School has three distinct roof areas: the EPDM flat roof over the main body of the building and the hip roofs over the East and West wings. The two roofs at the wings have similar materials and as such can be assessed as a group. Metal flashings, and gutters all need to be replaced or restored. Instead of by location, this narrative will be organized by material; asphalt and EPDM.

Organic growth on shingles can be removed via gentle cleaning, either with water or chemicals. When a sizable portion of the shingle exposure is missing, it can allow moisture to migrate and be absorbed into the subroof. During times of heavy rain and ice melt, this moisture can travel through minuscule openings in the subroof into the plaster and/or gypsum below. This is more often the process by which interior finishes are damaged. What is more: upon freezing, the trapped moisture can push up on the shingles and accelerate their breakage; this of course exacerbates the condition by which water is allowed to enter the envelope. *Asphalt Shingles with major breakage (3-5%) should be replaced in-kind matched to the color employed at the roof.*

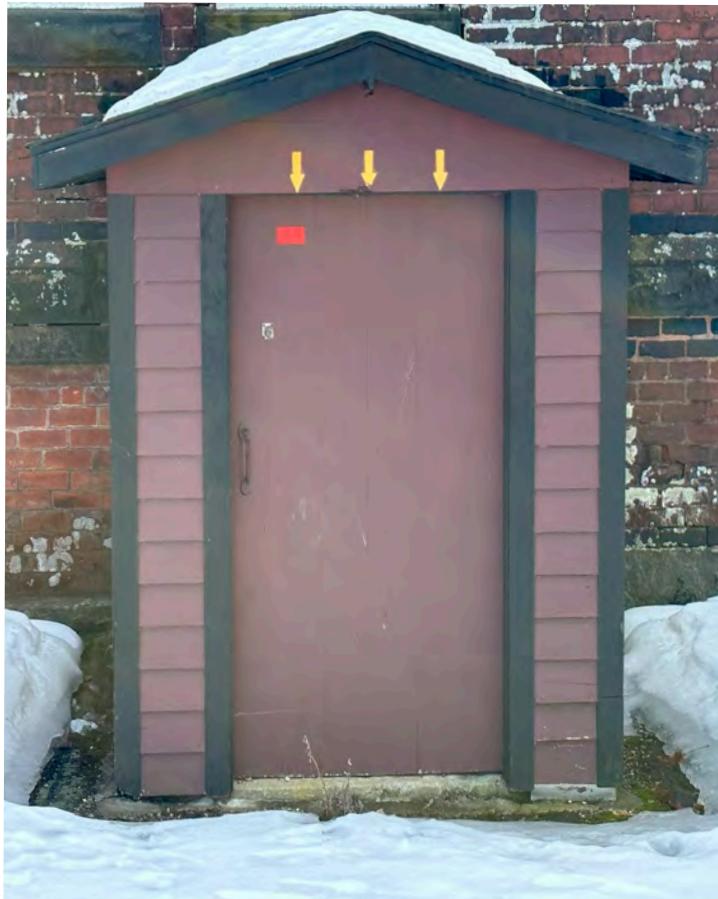
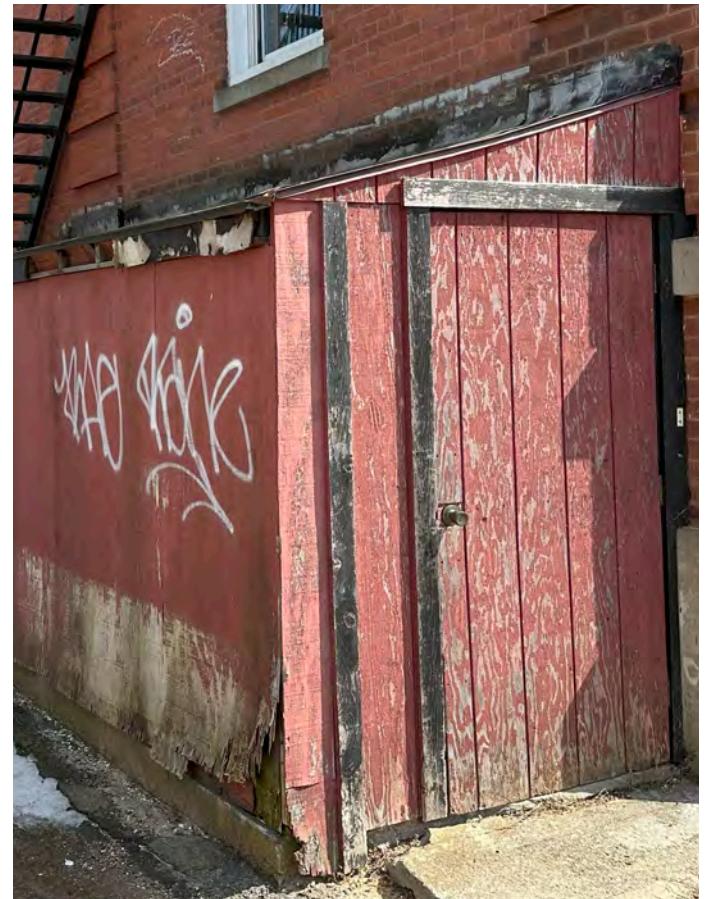
COVERED RAMPS: Both existing ramps to the existing gym do not meet code. Both must be demolished and replaced with code compliant ramps. Also a new covering for the ramps should be designed.
