SSV Architects
ARCHITECTURE • PRESERVATION

BUTTERFIELD SCHOOL FEASIBILITY & REUSE STUDY

CONDITIONS ASSESSMENT & TREATMENT RECOMMENDATIONS

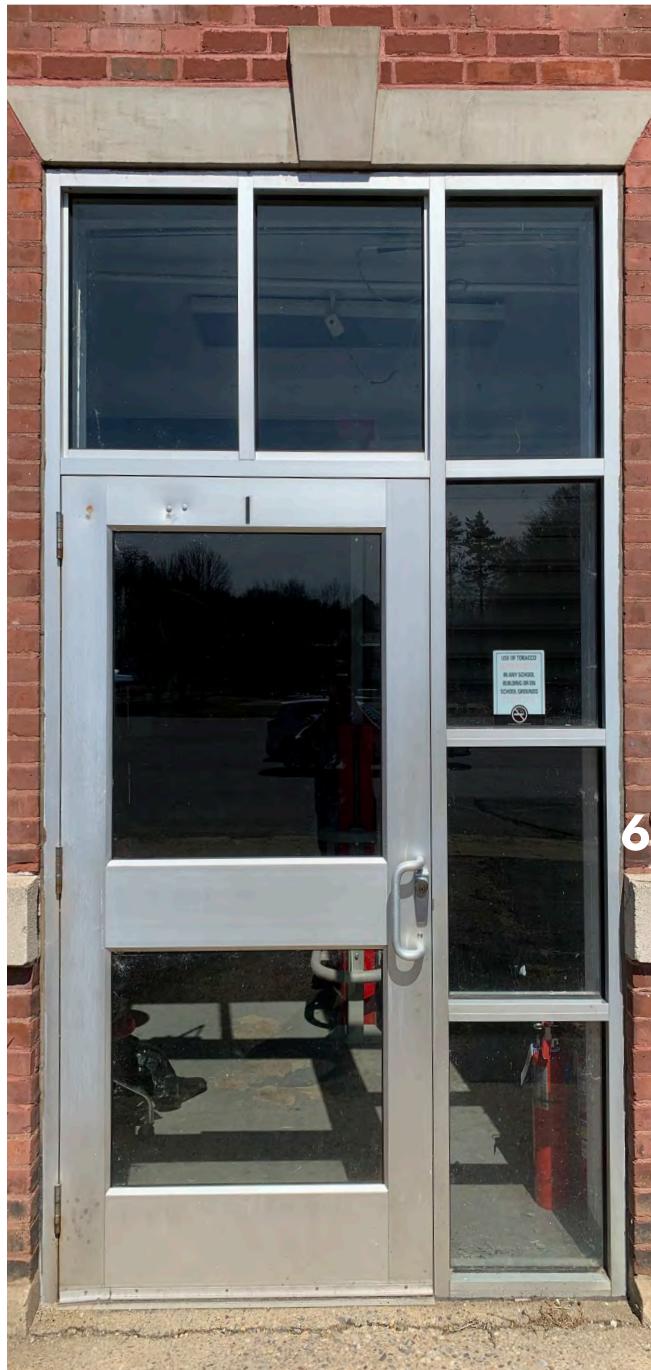
At the Butterfield School, the condition and functionality of the windows may vary considerably. This is particularly relevant as window enhancements often constitute a significant portion of our restoration efforts, especially in historic buildings. Typically, this need arises due to natural aging combined with a history of deferred maintenance.

The previously replaced windows appear to be functioning satisfactorily. We suggest that until the point of need of replacement, these windows would remain. When replaced, a thorough study of the old photographs of the original windows should be used so that the new windows would closely match the original windows a possible.
